SERVICE BULLETIN

AIRCRAFT EFFECTED: All models pre-2008
BULLETIN NUMBER: SB011
ORIGIONAL ISSUE DATE: 01-12-00
REVISION DATE: 01-02-19
SUBJECT: Control column torque tube cracks
APPLICABILITY: All KFA aircraft pre-2008
COMPLIANCE: Mandatory

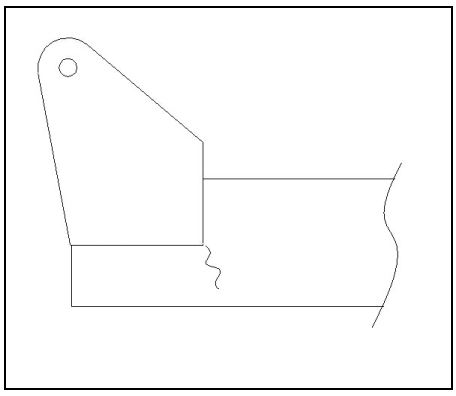
Problem: Cracks have been found on two occasions on the FCC control column torque tube, **left rear side**.

Solution: Remove the blue bearing block and inspect torque tube for cracks at every 100 hour or annual inspection.

If any cracks are found, send the part back to KFA for replacement or repair.
